## Early construction at Mundaring Weir, c1898

### Description

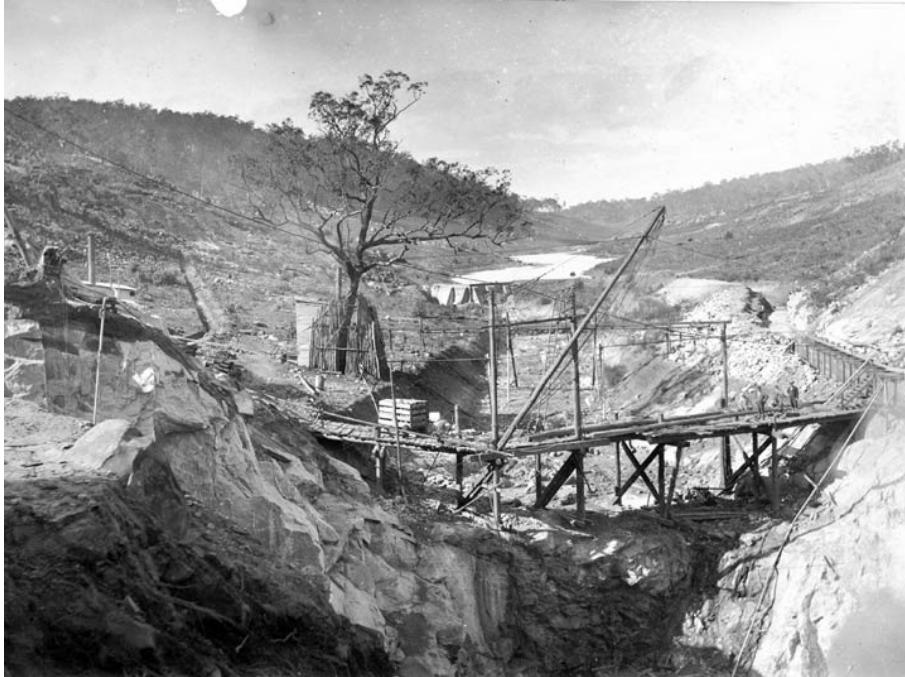
This is a black-and-white photograph taken about 1898 that shows an early stage in the construction of the wall of the dam built to store water for the Coolgardie Water Supply Scheme, which supplies Western Australia's eastern gold fields. A temporary dam to store water for construction purposes can be seen in the background. The steep granite slopes of the river valley chosen for the dam site are evident in the left foreground. People are standing on the temporary platform on the right, and buildings can be seen on the left and in the centre. The photograph measures 15 cm x 20 cm.

- The site chosen for the storage dam for the Scheme was the bottom of a deep valley on the Helena River, 50 km from Perth, and excavation for the foundations of the dam wall began in April or May of 1898. In this photograph the deep excavations to reach bedrock are still underway. They eventually descended more than 30 m.

- According to engineer T C Hodgson, the granite bedrock, narrow valley and precipitous sides that are visible in this photograph made the site 'almost an ideal

one' for a storage reservoir. In his report to engineer-in-chief C Y O'Connor, Hodgson recommended that a high wall be built but stated that it did not need to be wide. The dam wall would later take shape immediately in front of the working platform visible in the photograph. A large type of crane known as a derrick crane was used to manoeuvre heavy loads, such as the large granite boulders that would be embedded in the concrete wall.

- The coffer, or temporary holding dam, built a short distance upstream of the future reservoir, and the diversion flume built to direct water around the wall's foundations can both be seen. These were the first works to be undertaken following the construction of a railway line to the site.

- The concrete coffer provided water for the many men working on the site as well as for construction, for example for mixing with cement, sand and aggregate to make concrete. The diversion flume was capable of carrying away nearly 380 million L of water per day. It was largely an open-cut channel but a timber flume was also constructed to carry floodwaters across the weir site to keep it dry.

- The dam's problematic rock foundations are visible in the photograph. When work on the dam began the rock proved to be far less solid than trial shafts had indicated. On the right bank a large portion of what was thought to be bedrock turned out to be an immense boulder with a large cavity below it. When he heard the news, O'Connor rushed to the site on 26 December 1899 and spent two days examining every aspect of this unexpected problem. He decided that work should continue although additional excavations to reach bedrock would be necessary. Removing the boulder delayed completion of the project by a year.
