Laying pipes across the Darling Ranges, c1902

Description

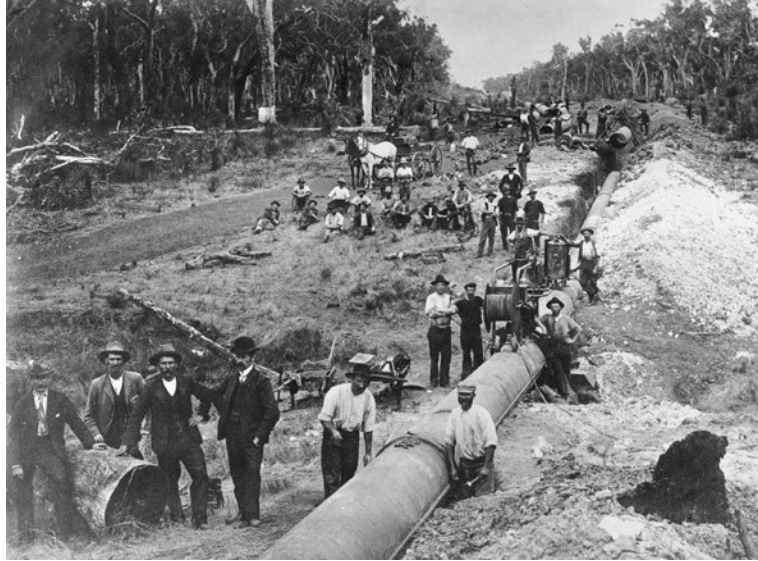
This is a posed black-and-white photograph showing the laying and jointing of a section of the Coolgardie Water Supply pipeline to Western Australia's eastern gold fields. It shows a number of people working in terrain typical of the forest country in the Darling Ranges and indicates the extensive timber clearing that was undertaken. Many lengths of pipe are laid out into the distance alongside the excavated trench. In the middle distance a team of workers is lowering a length of pipe into the trench using a pair of A-frame hoists. Several lengths of pipe are in place, complete with their joint rings, in the middle foreground. Closer to the foreground a caulking (joint-sealing) machine is set up above a pipe joint. The photograph measures 11 cm x 15 cm.

- The photograph is significant because it shows all the main steps involved in building the pipeline, which were laying the pipes, joining the pipe lengths and waterproofing the joints. Workers are seen lowering the next length of pipe into the pipeline trench. The cylindrical lead machine is following four or five pipe-lengths behind, pouring molten lead into the rings placed around the pipe joins. The caulking machine with its coiled cable then waterproofs the joints. In the foreground two men are finishing off a new machine-caulked joint by hand before the joint inspector gives approval for the pipe to be buried.

- There were logistical problems involved in building the part of pipeline shown. The Darling Ranges terrain was the most difficult the pipeline had to cross, being uphill and through thickly wooded forest. This particular section is not adjacent to the railway line so the pipes could not be brought directly by train. The track evident in the photograph probably leads to the nearest siding or station, from where materials would have been transported by horse-drawn carts. A swathe has been cut through the forest to accommodate the track and the pipe-trench. Clearing of heavy timber at the time would largely have been done by hand.

- The hilly terrain of the Darling Ranges near the storage dam for the Coolgardie Water Supply Scheme is evident from the different ways in which the pipeline is being laid to ensure correct alignment. One section is above ground on concrete bolsters while another is to be buried in a particularly deep trench. A deliberate decision was made not to follow the contours of the hills in this area, as the railway line did, in order to shorten the distance and reduce the pressure on the pipes in higher country.
