Lead melting machine for caulking, 1901

Description

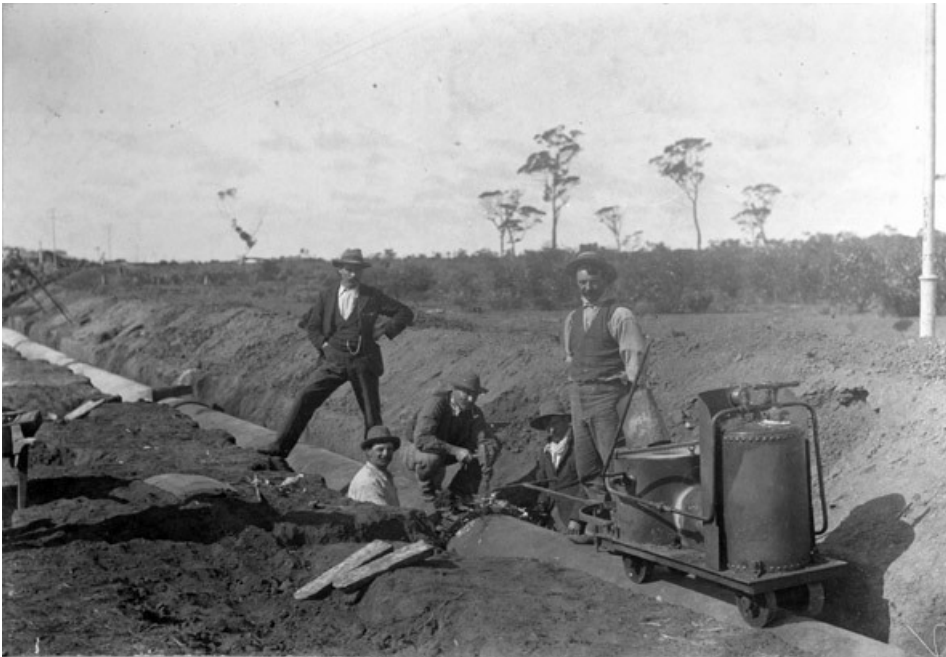
This is a black-and-white photograph of a group of five men gathered in and around the trench of part of the Coolgardie Water Supply pipeline. The men are posed around a joint between two lengths of pipe. On the pipe is a machine for melting the lead used for caulking (sealing) a joint. The men are formally dressed in hats, coats and even waistcoats, although conditions appear both hot and dirty. The photograph measures 21 cm x 16 cm.

- Lead-running gave great trouble until the lead-smelting machine, shown in the photograph, sped up and simplified the process. Until the lead-smelter was devised, the lead tended to run out before cooling and solidifying tight. Use of the machine eliminated 'honeycombing' and other faults that had previously been experienced. The lead machine carried an acetylene gas generator, with the gas being burned in a small furnace beneath the pot holding the lead for melting.

- Caulking was a time-consuming process and a highly skilled construction stage at which individual pipe lengths were joined using a sealing process that ensured the pipeline did not leak. High quality caulking was essential to the success of the pipeline.

- The particular stage of caulking that involved plugging the gap between the ring and pipes with lead was known as 'lead-running' and involved pouring molten lead into a funnel at the top of a collar around the joint, from which it would work its way down to the bottom, gradually filling the gap.

- Lead-runners, some of whom are shown with the smelter, were specialist labourers who worked 40 or 50 joints ahead of the caulking machine to prevent delays and followed the ring setters who placed the rings.

- Uncomfortable conditions on the pipeline, such as those seen in the photograph, made it difficult for caulkers to produce uniformly good work and this led to the invention of the caulking machine. Caulkers had to spend long hours in cramped, exposed conditions in the pipe trench. Small circular areas were excavated at distances corresponding to the joints, but gave little room to manoeuvre. Packing lead by hand was particularly difficult on the underside of the pipe, since the men were virtually working upside down. The steel pipe became 'sprung' under even a light blow from a caulking hammer. Making a 100 per cent waterproof joint was almost impossible. In contrast, the machine applied equal pressure on both sides of the pipe and joint ring.
