Manufacturing joint rings, c1902

This black-and-white photograph shows two men at Mephan Ferguson's pipeworks in Falkirk, a suburb of Perth now known as Maylands. The men are in the process of welding joint rings for joining pipes to be used in the Coolgardie Water Supply pipeline. One man is heating a collar of steel over an open-hearth fire while the other is manipulating a second ring. Both men are using long-handled tongs to hold the collars. The photograph measures 21 cm x 16 cm.

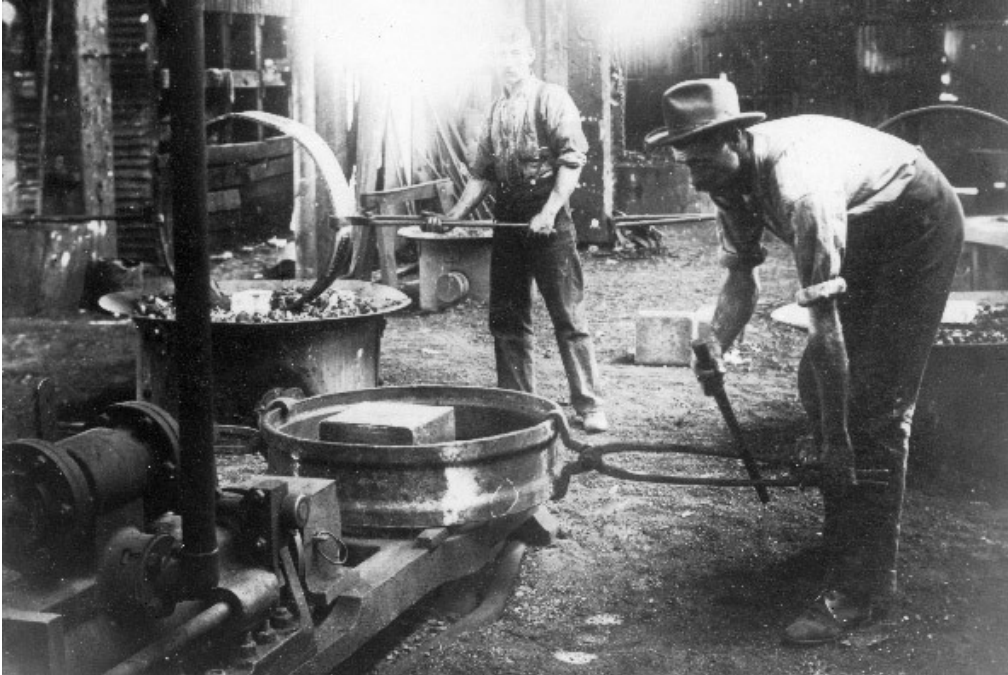
- The men shown are working on a connecting piece called a joint ring, or thimble, designed for joining pipe lengths to create the pipeline. To make such rings, flat steel sections supplied by steelworks in England were shaped and welded by a blacksmith and his mate, first hammering each end into a 45-degree-angle wedge before a hydraulic press shaped the steel into a ring.

- The photograph shows the ends being heated in a forge until red hot, when they became malleable, prior to being welded into a continuous ring by a steam

hammer, shown at front left in the photograph. A 'bulge' was then created on opposite sides of the ring, using heat and pressure, to accommodate the ends of the two locking bars that ran the length of each pipe and held the pipe halves together.

- The men are using long-handled tongs but there is little other evidence of concern for occupational safety, such as gloves. The men are wearing their everyday clothes and no safety glasses or steel-capped boots. The floor is the one concession to safety, although trip hazards are evident. It has deliberately been left as dirt so that burning embers escaping from the fire will quickly be extinguished. Temperatures would have been unbearable during Perth's hot summers in a corrugated iron shed with a fire, yet there is no evidence of any form of cooling.

- The work shown in the photograph is an example of forge welding, a method of joining metals used since ancient times in which two or more pieces of metal are heated until their surfaces are molten and then hammered together. Historically, the hammering would have been done by hand but, by the time these joint rings were being made, a steam-powered hammer had been invented. Forge welds are strong because during forging (heating) the metal's structure changes, making it stronger and more ductile.

- In the days before welding was common, joining pipes in the field required innovation. In the case of the Coolgardie Water Supply pipeline, the pipes and rings were delivered to the pipeline construction sites by rail. The pipes were then laid end to end, pushed as close together as possible and a joint ring fitted around the join between two pipe ends to act as a 'cover plate'. Molten lead was packed into the 6-mm space between the ring and pipe and it solidified to make the joint waterproof. The Coolgardie Water Supply pipeline required 60,000 joint rings.
