Pouring lead for a waterproof joint, 1901

Categories: The Pipes

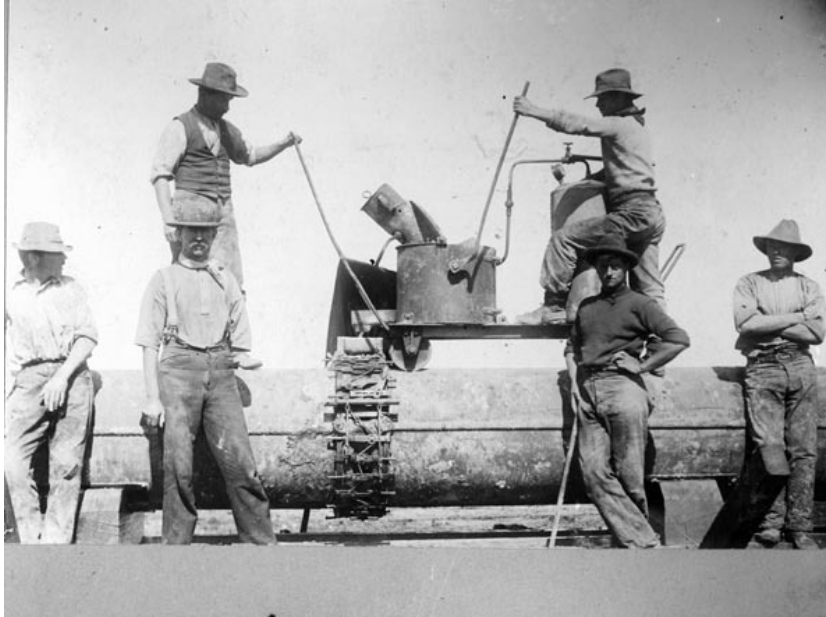
This black-and-white photograph shows six men posed around the joint linking two lengths of pipe in the Coolgardie Water Supply pipeline. Two are operating a machine that melts lead for caulking (sealing) a waterproof joint. A collar of short bars interlinked by wires and chains can be seen around the joint. The photograph measures 21 cm x 16 cm.

- Caulking involved manoeuvring a new pipe into place flush with the last pipe laid, with a connecting piece called a ring (hidden under the collar around the pipe in the photograph) between the two. The gap between the ring and pipes was first filled with lead. An electrically powered caulking machine forced the lead into the joint, then hand caulkers sealed the joint around the locking bar.

- The particular stage of caulking that involved plugging the gap between the ring and pipes with lead was known as 'lead-running'. Before the lead-running stage, about 10 cm of coating was chipped off each end of the pipe. Once the pipes and ring were in place and lined up correctly, the gap was packed by hand with hemp rope to absorb the lead. Then the collar was fitted and clamped. Lead-running commenced when the molten lead was poured into a funnel at the top of the collar, from which it would work its way down to the bottom, gradually filling the gap.

- Lead-running gave great trouble until the lead-smelting machine, seen in the photograph pouring molten lead into the joint, sped up and simplified the process. Until the lead-smelter was devised, the lead tended to run out before cooling and solidifying tight. Use of the machine eliminated 'honeycombing' and other faults that had previously been experienced. The lead machine carried an acetylene gas generator, with the gas being burned in a small furnace beneath the pot holding the lead for melting.

- The locking bar, a unique clamping mechanism used for the pipes in the Coolgardie Water Supply Scheme, runs the length of each completed pipe and the pipes are shown joined with their locking bars parallel to the ground. More than half of the original pipe laid between 1900 and 1902 is still in use today. Original pipes can easily be identified by the horizontal bar. When the pipeline was refurbished in the 1930s, the pipe lengths were laid with their locking bars at an angle to spread areas of potential weakness.

- The photograph gives an unusually clear view of the lead-running process because this is a section where the pipeline was being laid above ground on wooden collars. The pipeline was originally buried in a trench wherever possible so most photographs do not allow a view of the underside of the pipe. This photograph was probably taken near No 2 Pumping Station, about 2 km from the storage dam for the Scheme. In this hilly countryside the pipeline sometimes had to be laid across trestle bridges and sometimes in deep trenches to ensure correct alignment of the pipes.
