## Reservoir at No 2 Pumping Station, 1902

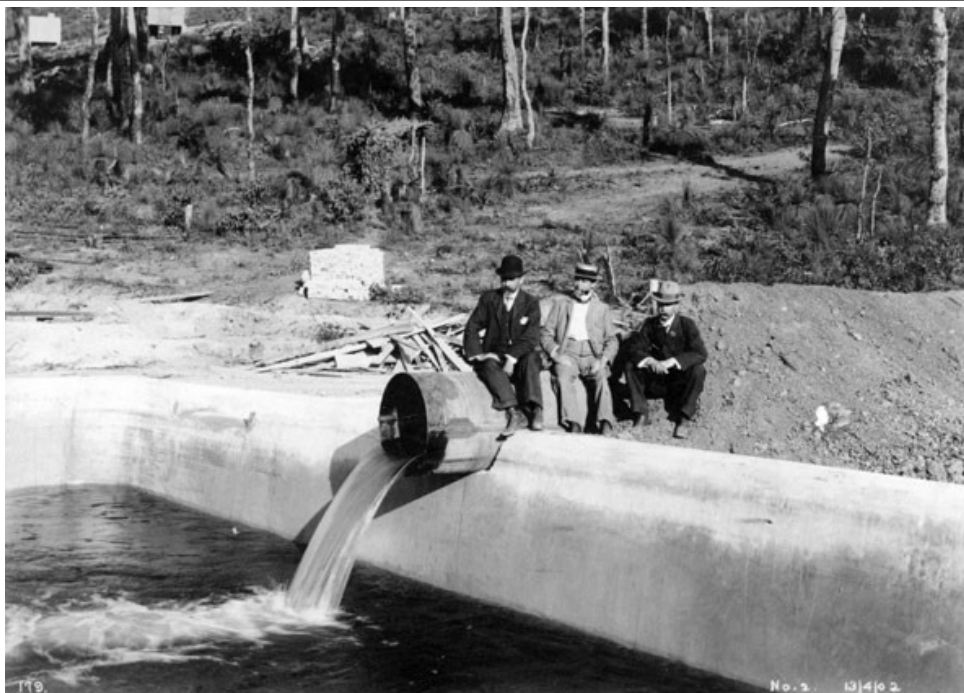
This is a black-and-white photograph showing three men, all of whom were involved with the completion of the water supply pipeline in Western Australia, sitting on a pipe that is discharging water into the suction tank of No 2 Pumping Station. The photograph, showing the tank nearly full, was taken on 13 April 1902, two weeks after pumping had started at No 1 Pumping Station. On the left, in the bowler hat, is T C Hodgson, then engineer-in-charge of all pipeline and pumping station construction. In the centre is attorney Reginald Forbes of Glanville and Forbes, who acted in Australia on behalf of the British firm that supplied the pumping machinery. On the right is William Reynoldson, who was to succeed Hodgson as engineer-in-charge of the Scheme. The photograph measures 15 cm x 11 cm.

- The Coolgardie Water Supply Scheme pumped water further and lifted it higher than ever before. It was designed as eight repetitive sections rather than one continuous pipeline. In the photograph, water is entering a tank that served as both a receiving and a suction tank at No 2 Pumping Station, after being pumped a vertical lift of almost 50 m from No 1 Pumping Station. Pumps in No 2 Pumping Station would have drawn this water and sent it to a reservoir at No 3 Pumping Station. No 3's engines would have sent it on to No 4 Pumping Station, and so on up the line. The tanks also served as service reservoirs for the pumping stations' residents.

- Corrosion became a problem almost as soon as the pipeline was completed, external corrosion by 1905 and internal corrosion by 1908. In this 1902 photograph the pipe is shown entering at the top of the tank, an arrangement that was then common to all pumping stations with such tanks. Later, the pipework was altered to discharge water near the bottom of the tank instead of above the surface of the water; this modification being made to prevent corrosion caused by dissolved oxygen. A report into pipeline corrosion made several recommendations, including adding lime to the water. Lime would have been added to the water in this tank between 1910 and 1913.

- The water seen in the reservoir had come from Mundaring Weir on the outskirts of Perth, on the first stage of its journey through a 560-km pipeline to the gold fields. It is flowing into the suction tank that served the second of the eight steam pumping stations needed to deliver the valuable water to its destination.

- As a protective measure, the steel pipes of the Scheme were covered with soil where possible and buried in a trench about 1 m deep, to insulate the joints from extremes of temperature. Where the pipeline could not be buried, for instance in saline soils where corrosion would occur, it was carried on timber trestles, insulated with sawdust and kept in place by galvanised corrugated iron to prevent movement at the joints. In the 1930s the pipeline was raised above ground level so that it would be clear of corrosive soils.

- Some of the sites chosen for the eight steam pumping stations were very remote and staff had to live onsite because there was nowhere else within reasonable distance. Visible in the photograph is a track that would have been made through the virgin bush specifically for the purposes of building No 2 Pumping Station.

- The tanks were fenced off to prevent animals from the surrounding forest or countryside falling in and polluting the water. The fence at No 2 Pumping Station was built to keep out wild horses.
