Electric caulking machine, c1902

Description

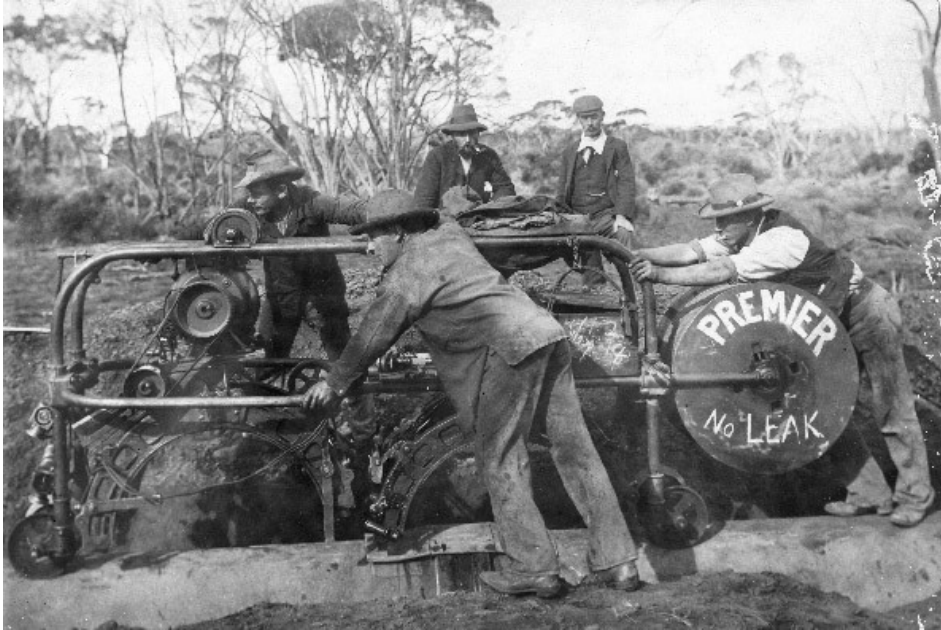
This is a posed black-and-white photograph showing three men, watched by two others, moving an electric caulking machine into place above a pipe joint for the Coolgardie Water Supply pipeline in Western Australia around 1902. The machine is mounted on a trolley that rolled on four wheels along the top of the pipe, from one joint to the next. The words 'Premier No Leak' have been painted on the machine's cable drum. The photograph measures 20 cm x 16 cm.

- The mechanised process of 'caulking' or waterproofing the joints in the water supply pipeline involved fitting caulking tools into the two half-circular frames seen in the photograph, one over the top of the pipe, the other underneath. The tools moved backwards and forwards, plugging any space between the pipes and the ring with lead to prevent leaks. Unlike manual caulking, a caulking machine applied equal pressure on both sides of the pipe and both sides of the joint ring. The electricity that powered the machine came from a generator (not visible).

- The photograph shows all the equipment, apart from the generator, used in the mechanised caulking process. As well as the caulking-machine itself, there was a wheeled trolley for ease of transport, a cable drum and portable oil-engine. The caulking machine was driven by an Australian-built spontaneous ignition engine. The electric motor can be seen on the frame of the machine that sits over the top of the pipe joint. The underframe of the engine carried a dynamo belt-driven off the engine flywheel. Current was transmitted through a cable coiled on a drum attached to the back of the trolley. A plug connected the cable to the motor and the motor was belt-connected to a shaft which worked the racks holding the caulking tools by intermediate gears.

- This electric machine was designed to minimise hand-caulking by men using caulking hammers, tools that looked like blunt chisels, to force lead into a ring placed around the join between two pipes. It was also intended to improve the

quality of the joints since men working in cramped, exposed conditions for long hours in the pipeline trench could not produce uniformly good work.

- Caulking by hand was slow, and experienced and skilled caulkers were scarce. The steel pipes moved under even a light blow from a caulking hammer, making a totally waterproof joint almost impossible. Packing lead by hand was particularly difficult on the underside of the pipe, since the men were virtually working upside down.

- Invented by James Couston, the electric caulking machine promised to speed up the rate of joining the 60,000 pipes in the 560-km long pipeline but, when the first machines went into service in March 1901, they were not as efficient as hoped because the operators needed extensive training and experience. Although trials showed machine-caulked joints remained watertight at hydraulic pressure of 2.76 megapascals, whereas hand-caulked joints would leak slightly, the gains in efficiency were reduced because the areas around the locking bar longitudinal joints still had to be finished off by hand.

- The photograph shows a caulking team, which included three men to work and transport the machine, a mechanic for the engine and dynamo, and two hand-caulkers to finish off the lead joint (their tools are probably wrapped in canvas on top of the trolley). The other two men in the photograph are probably an inspector and a supervisor, who were responsible for ensuring quality work, an indication of the importance of effective joints. The workers' clothes include hats, coats and waistcoats, despite the hot and dirty conditions, while the supervisors appear in full three-piece suits.
