Flume at Karalee Rocks, 2002

Description

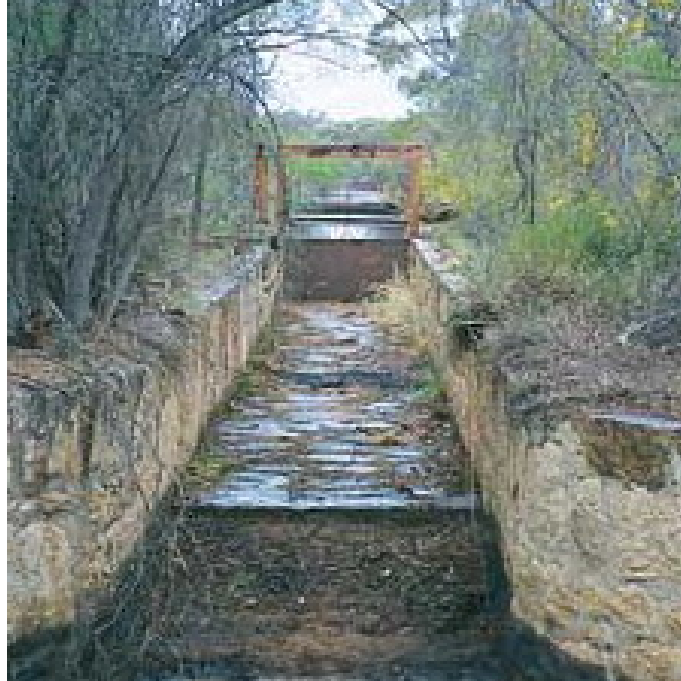
This is the entrance to a steel flume built to take rainwater, running off a granite outcrop, to a dam. A low perimeter wall has trapped run-off from the rock. A sluice gate in the centre of the photograph is lowered, blocking the channel. The colour slide was taken in 2002 at Karalee, approximately 50 km east of Southern Cross.

- This asset shows a wall built around a granite outcrop channelling rainwater into a flume that leads to a dam - this system was used to obtain fresh water in the 1890s in Western Australia's arid interior; the perimeter wall prevents run-off from dissipating into the soil at the base of the rock; the run-off is directed to a collection point and through a narrow channel to a storage dam built at the lowest point at the base of the rock.

- It illustrates features typically incorporated in rock catchments - stone slabs, a sluice gate and silt trap; rough square blocks have been used in the perimeter wall, which were quarried from the rock itself; the step at the entrance acts as a barrier, preventing debris and silt from entering the channel and hence the dam; the sluice gate has a large rock as a counterweight and can be raised to allow an

inflow of water; when the 48.3-million-L dam was full the gate would be lowered and another opened to redirect water into the surrounding bush.

- It features an unusual flume for channelling water into the dam - most rock water catchments have rock-lined channels to direct run-off into their associated storage dams; however in this case there is also an elevated steel flume 206 m in length that carries the run-off from both the largest of the two rocks at Karalee as well as from the smaller of the two rocks; the flume can be glimpsed beyond the rock-lined entry through the sluice gate frame in the photograph, stretching into the distance; this flume has been conserved by the National Trust of Australia (WA) for its heritage value.

- It is typical of the water collection and storage system for the railways in the 1890s - steam engines used copious amounts of water; to prevent scale, steam locomotives' boilers required the mineral-free water which rock run-off provides; these systems were constructed for the railways in particular and water supply in general, hence they are often known as 'Railway Dams'; water from Karalee's dam was pumped 3.6 km to the railway line; railway contractors built more than a dozen such storage tanks and water catchments while extending the railway line to Southern Cross in 1894 and on to Coolgardie and Kalgoorlie in 1896.
