No 2 or Bennett's Tank, Coolgardie, 1895

Description

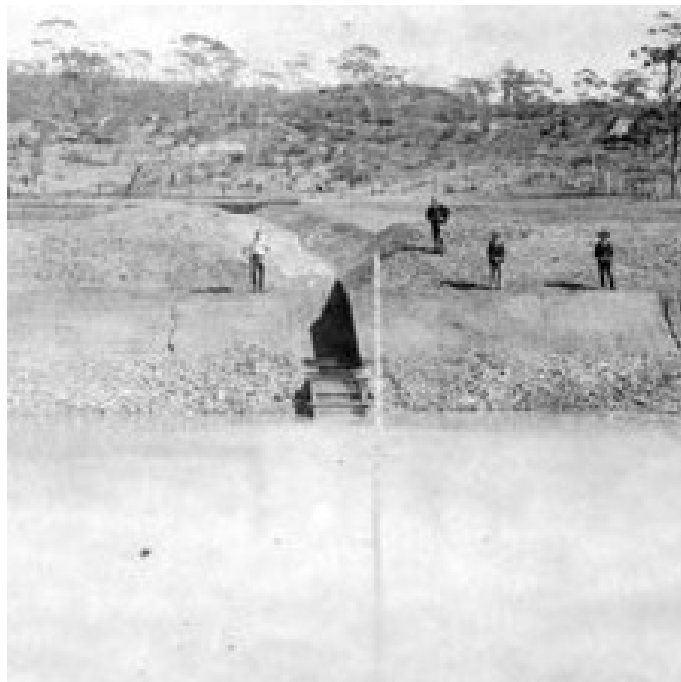
This is a sepia photograph measuring 15 cm x 21 cm showing Bennett's Tank, which was developed by the Western Australian Government on the eastern gold fields as a source of fresh water for transport and people before the Coolgardie Water Supply Scheme was opened. Rain falling on the low hills and slopes in the background drains naturally into it. The sluice through which the water enters the tank is visible at its rear. The sides of the tank are terraced. A depth marker near the middle of the tank shows that the tank was far from full.

- It is an example of a 'Railway Dam' - these dams were constructed at regular intervals on the line between Southern Cross and Coolgardie to provide water for steam trains; the dams were situated at the base of granite outcrops to catch mineral-free run-off from the impervious rocks for train engines; because these dams proved inadequate, in 1900 the Railway Department started construction on the largest condensing plant in the gold fields, close to the train line at Coolgardie; this 'mammoth' condenser could convert 546,000 L of salt water a day into 455,000 L of fresh water.

- It is one of a range of tanks built in 1895 to meet the growing need for water in the Yilgarn and Coolgardie gold fields - 'tank' was the term used at the time for an excavated reservoir and this one is typical of the thirteen large and two small tanks constructed by the Western Australian Government in 1895 to provide a water supply for the general public as well as for the railways; a similar dam at Bullabulling features in prospector John Aspinall's 1895 diary as unusable because a man had drowned in it, 'not that people in this country are very particular, but the man was suffering from fever'.

- It shows one of the two tanks built in Coolgardie at great expense to solve the 'water question' - at a cost of £2,110 and with a capacity of 5,300,000 L, No 2 was the larger and more expensive of the two; by this time water, fresh and unpolluted, was needed for an estimated 5,000 people in the town and up to 20,000 in the field.

- It is an example of an unsuccessful method of water supply in the gold fields - low rainfall combined with high evaporation rates meant dams were not the answer; Kalgoorlie's annual rainfall is 26 cm and the annual average evaporation is 266.4 cm; the average evaporation rate in January is 1.27 cm per day, but on a hot, windy day evaporation can be more than 2 cm; this photograph was taken on 6 June in 1895, at the beginning of winter when rains were particularly welcome because the lower temperatures meant the water would not evaporate at the same high rate as in summer.

- It provides information on the construction and siting of tanks - the dam is situated at a low point in the landscape and the sides are stepped; the excavation is lined with impervious clay to limit seepage of water into the earth below; upper levels are lined with rocks, to stabilise the banks and limit erosion and the tank is fenced for protection; there may have been a series of tanks to intercept and direct as much of the running water as possible; at first, due to ignorance of climatic factors in this newly inhabited region, tanks were built in poor locations and failed to catch water; suitable holding ground was limited and extremes of temperature caused concrete linings to crack.
