Water Corporation pipe probe, 1994

Description

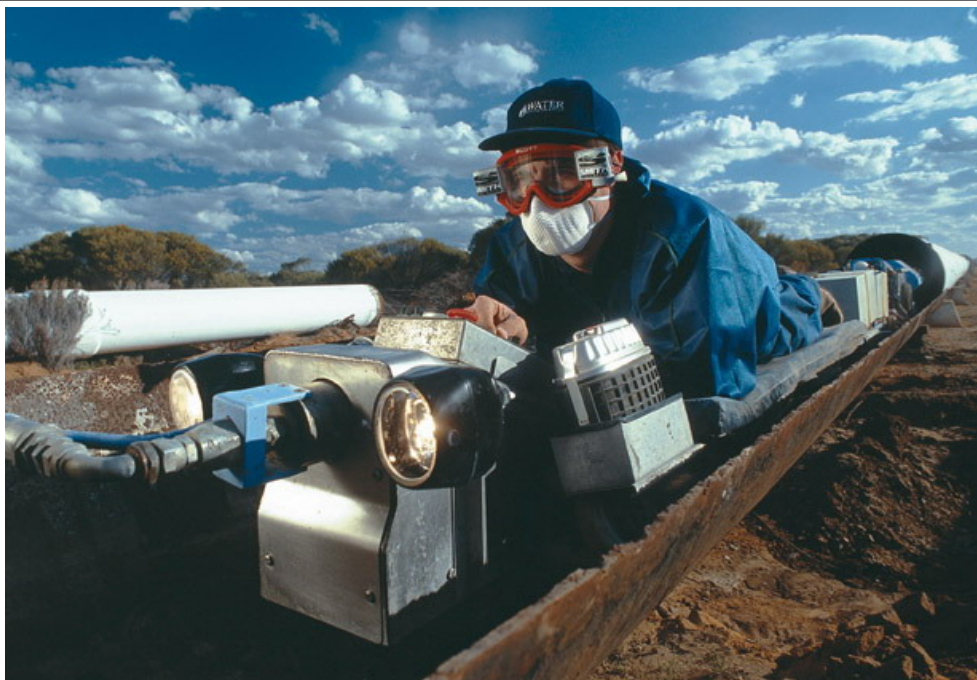
This is a colour digital photograph of 1994 showing equipment used in refurbishing the cement lining of the pipeline that delivers water to Western Australia's eastern gold fields. The top half of a section of pipe has been cut away to give a view of the operator lying on his front on a trolley inside the pipe.

worldwide review of available technologies found that there was none suitable. The equipment shown here was developed after a 5-year research and development program.

- Remotely controlled equipment and processes developed by the Water Corporation of Western Australia are used for the inspection, maintenance and refurbishment of large-diameter pipelines under pressure. The technology won the 1999 Institution of Engineers State Award for Engineering Excellence in the Maintenance Management category and now has worldwide patent protection.
- The equipment has been continuously improved since it was first developed in the early 1990s. The Challenger Pipeline Inspection System uses remote control inspection vehicles, video equipment and fibre-optic technologies to collect data on the condition of pipelines. Remotely controlled vehicles remove damaged cement mortar lining with high-pressure water blasting and apply new lining using a centrifugal process, but the lining is still finished off by hand.
